# Hydrological, vegetation, greenhouse gas and GEST monitoring in project sites in Latvia

## 2<sup>nd</sup> Monitoring Report

LIFE21 - CCM - LV - LIFE – PeatCarbon

Peatland restoration for greenhouse gas emission reduction and carbon  
sequestration in the Baltic Sea region

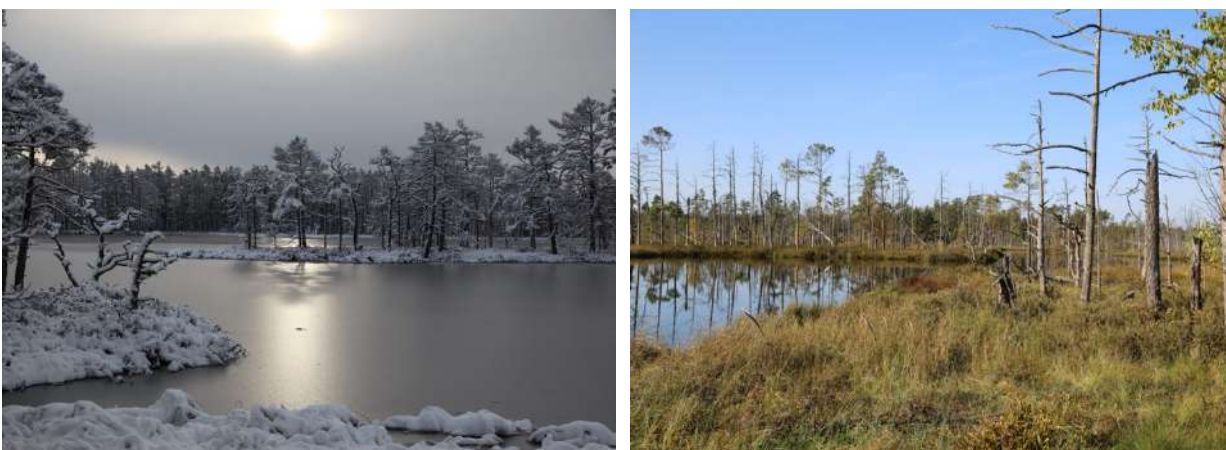
**Figure 1.2.** Success of previous hydrological regime restoration around Lake Skaista is indicated by pine decay. Situation in 2006 short before activities (left) and in 2024 (right). Images: © M. Pakalne

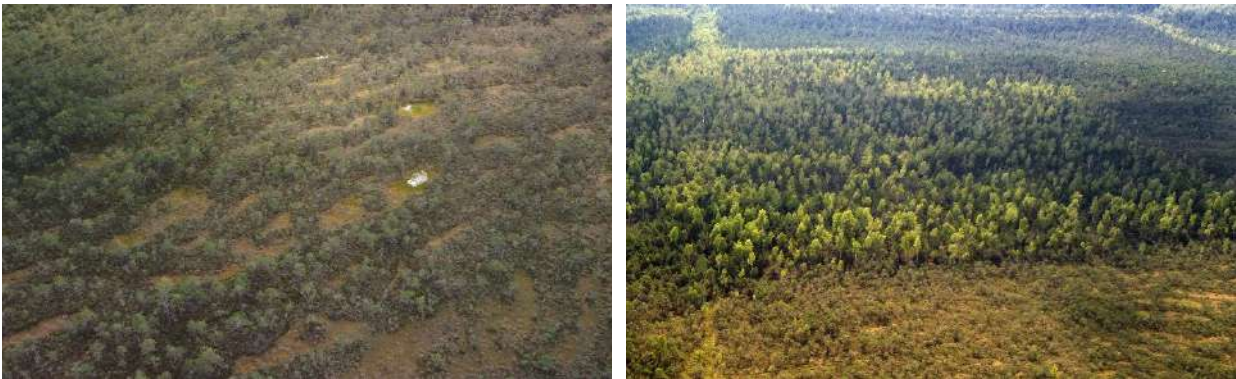
**Figure 1.5.** *Hollow-bog pool-ridge relief in the natural active raised bog (left) strongly contrasts with the almost square-shaped drained area that has overgrown by birches and pines (right) in Lielais Pelečāre Mire. Drone image: © J. Matuko*

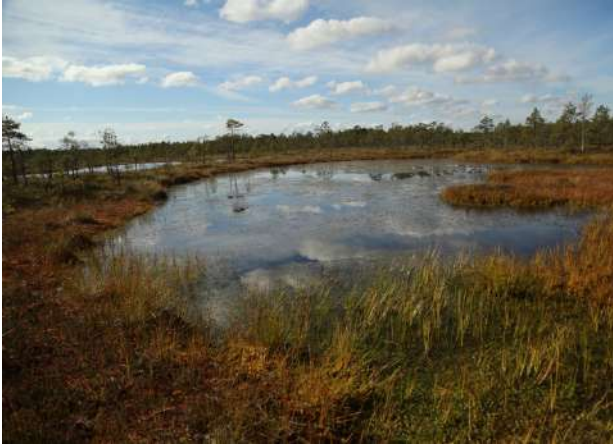
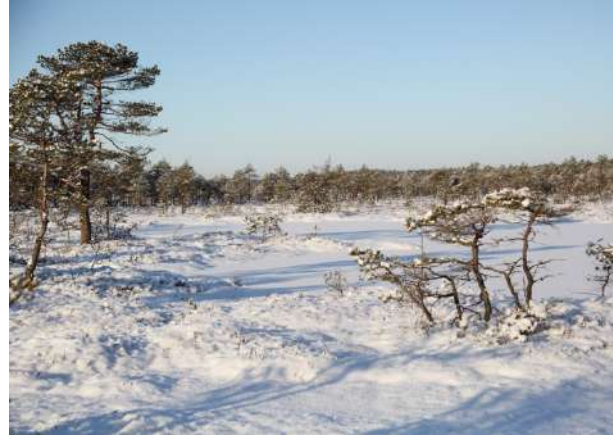
**Figure 1.6.** Active raised bog (left) and degraded part in 2024 where restoration has been completed in 2017 (right) in Sudas-Zviedru Mire. Images: © M. Pakalne

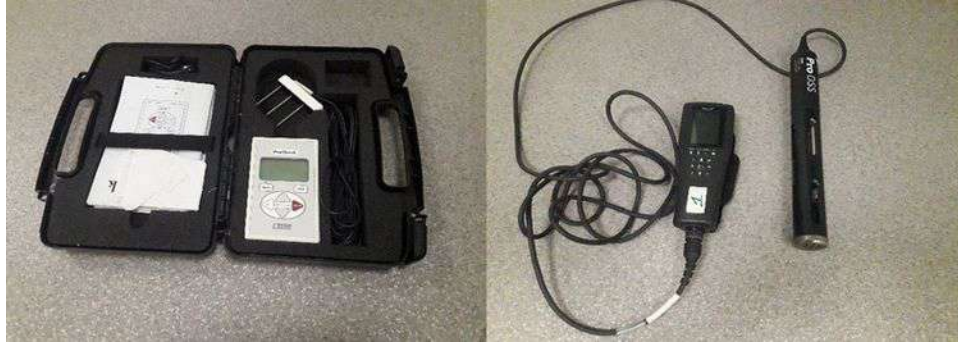
**Figure 2.3.8.** Equipment for measuring soil temperature, moisture content and groundwater properties. Image: © G. Saule

Simultaneously with the measurement of groundwater level, measurements and observations of factors affecting ecosystem GHG exchange are performed. Typically, groundwater characteristics such as depth, temperature, dissolved oxygen (DO), electrical conductivity, pH and oxidation-reduction potential (ORP) are determined with the ProDSS probe, as well as groundwater samples are collected for determination of the composition of ( $\text{NO}_3^-$ ) and ammonium ( $\text{NH}_4^+$ ) ions, as well as other parameters in the laboratory. In parallel, air and soil temperature measurements are performed at a depth of 5 cm, as well as soil electrical conductivity and soil moisture level are determined with Procheck (Figure 2.3.8.).

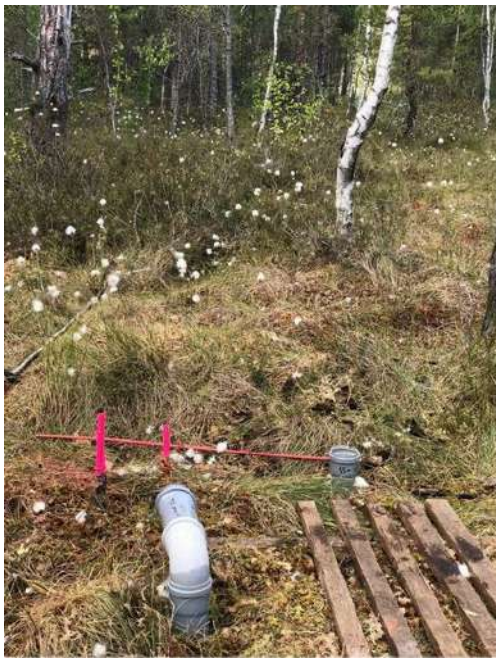
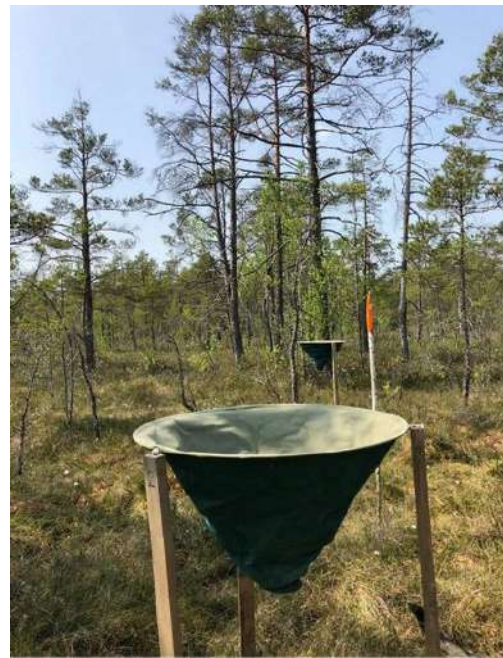
**Figure 2.3.9.** Water and litter sampling plots. Image: © G. Saule

Litter collectors (Figure 2.3.9) are installed on the outer perimeter of the plot, 10-15 m from the centre (3 pcs. in each plot) and are emptied once a month, simultaneously with gas exchange measurements. The total dry matter mass, as well as the carbon content, are determined for the litter. Large litter is not evaluated in this study, if carbon input because of natural branching or falling larger tree debris is small. The ICP Forests methodology (Ukonmaanaho et al., 2016) was used for litter collection and analysis.

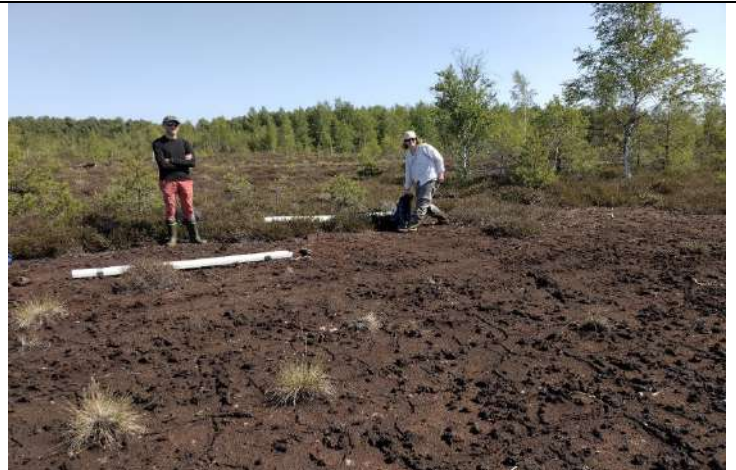
**Figure 3.1.4.** Installation of the water level monitoring well Cena4 in the degraded part of the Cena Mire, PeatCarbon restoration site, June 8, 2023. Image: © A. Kalvāns

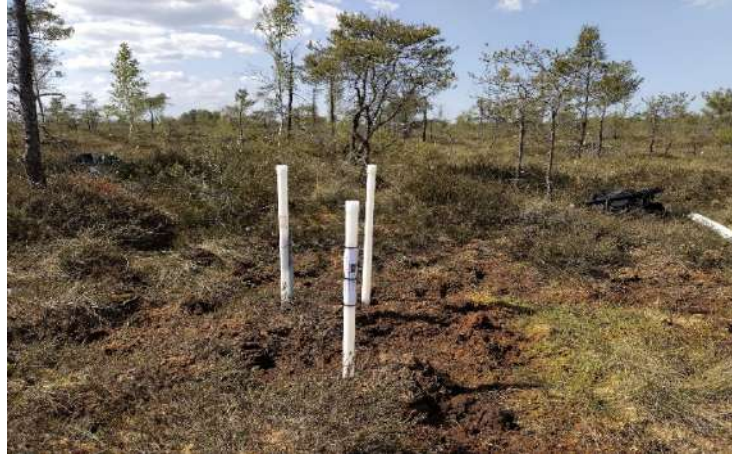
**Figure 3.1.7** Water level monitoring wells Cena3-1, Cena3-2 and Cena3-3 in relatively undisturbed part of the Cena mire, Jun 8, 2023

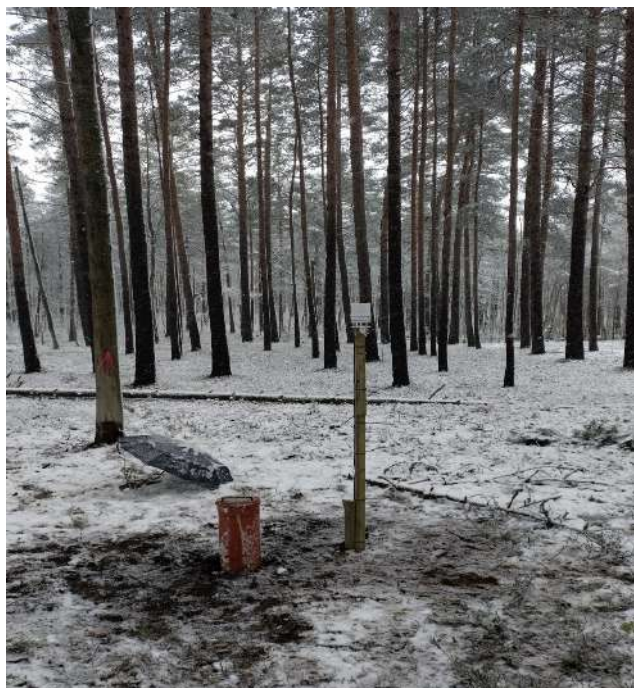
**Figure 3.1.14.** *One of two weather stations for microclimatological analysis and data logger at the Pelecare\_a1\_mezs observation site near well Pelecare1. Image: © A. Kalvāns*

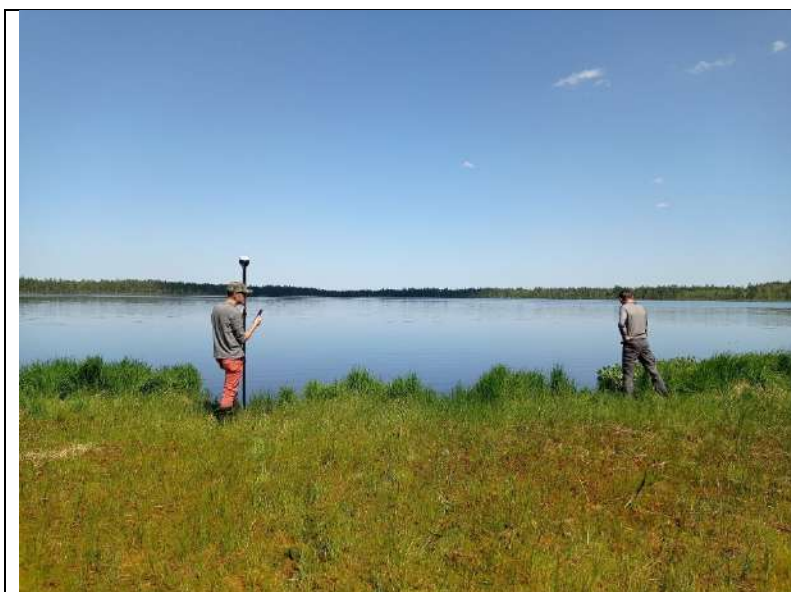
**Figure 3.1.16.** *Installation of the water level monitoring equipment at the floating shore of the Lake Deguma, June 20, 2023. Image: © A. Kalvāns*

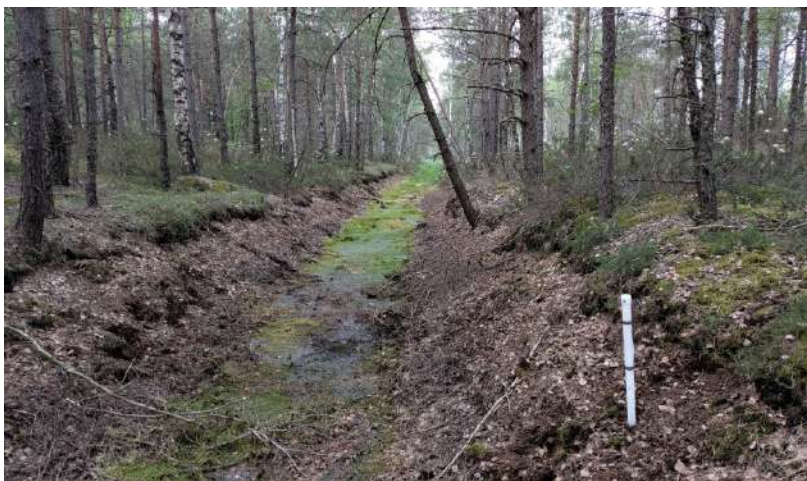
**Figure 3.1.30.** Monitoring well Melnais6 installed in the successfully blocked ditch in Melnais Lake Mire, May 29, 2024.

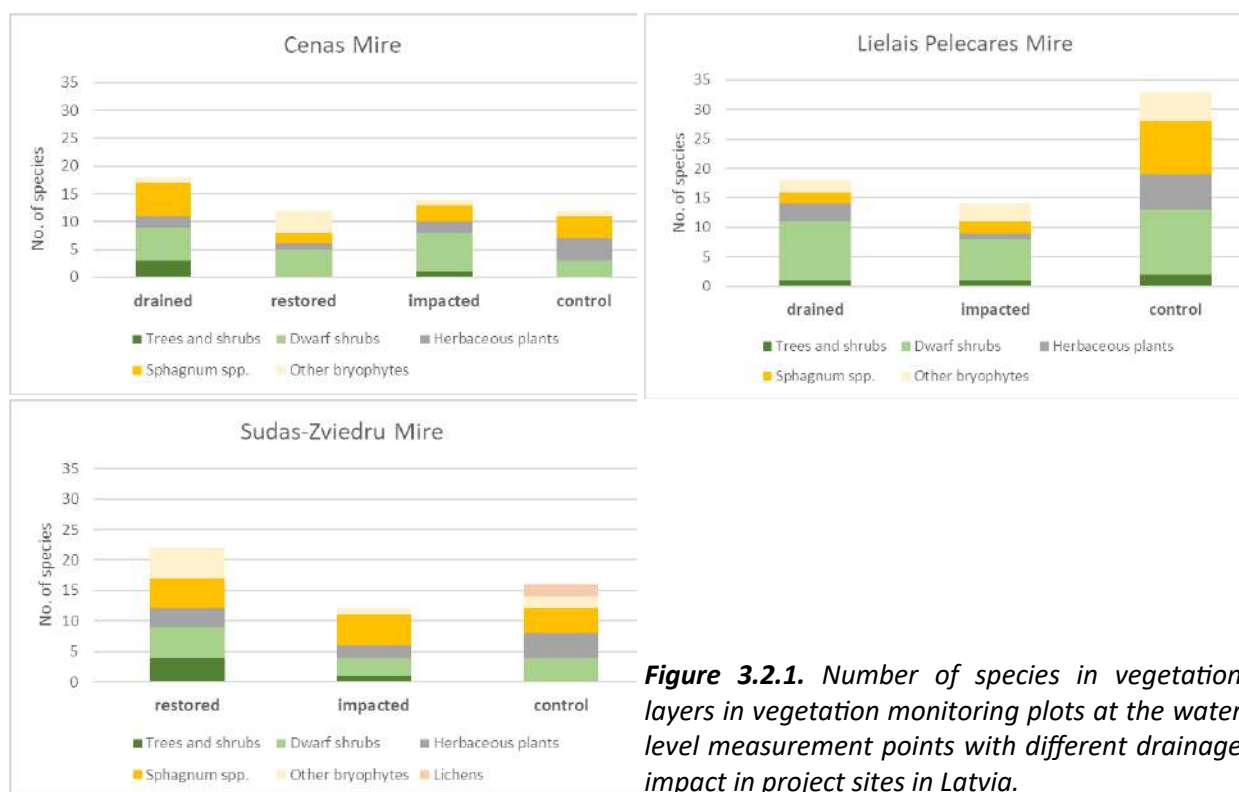
**Figure 3.2.1.** Number of species in vegetation layers in vegetation monitoring plots at the water level measurement points with different drainage impact in project sites in Latvia.

The lowest number of species was found in Sudas-Zviedru Mire with 32 species (Appendix 6.6). Altogether, 68 species were found at least in one monitoring plot. Some of the most common species that were recorded in all project sites are *Betula pendula*, *Pinus sylvestris*, *Andromeda polifolia*, *Calluna vulgaris*, *Drosera rotundifolia*, *Empetrum nigrum*, *Eriophorum vaginatum*, *Ledum palustre*, *Oxycoccus palustris*, *Rhynchospora alba*, *Rubus chamaemorus*, *Vaccinium uliginosum*, *Dicranum polysetum*, *Pleurozium schreberi*, *Sphagnum cuspidatum*, *S. fuscum*, and *S. medium*.

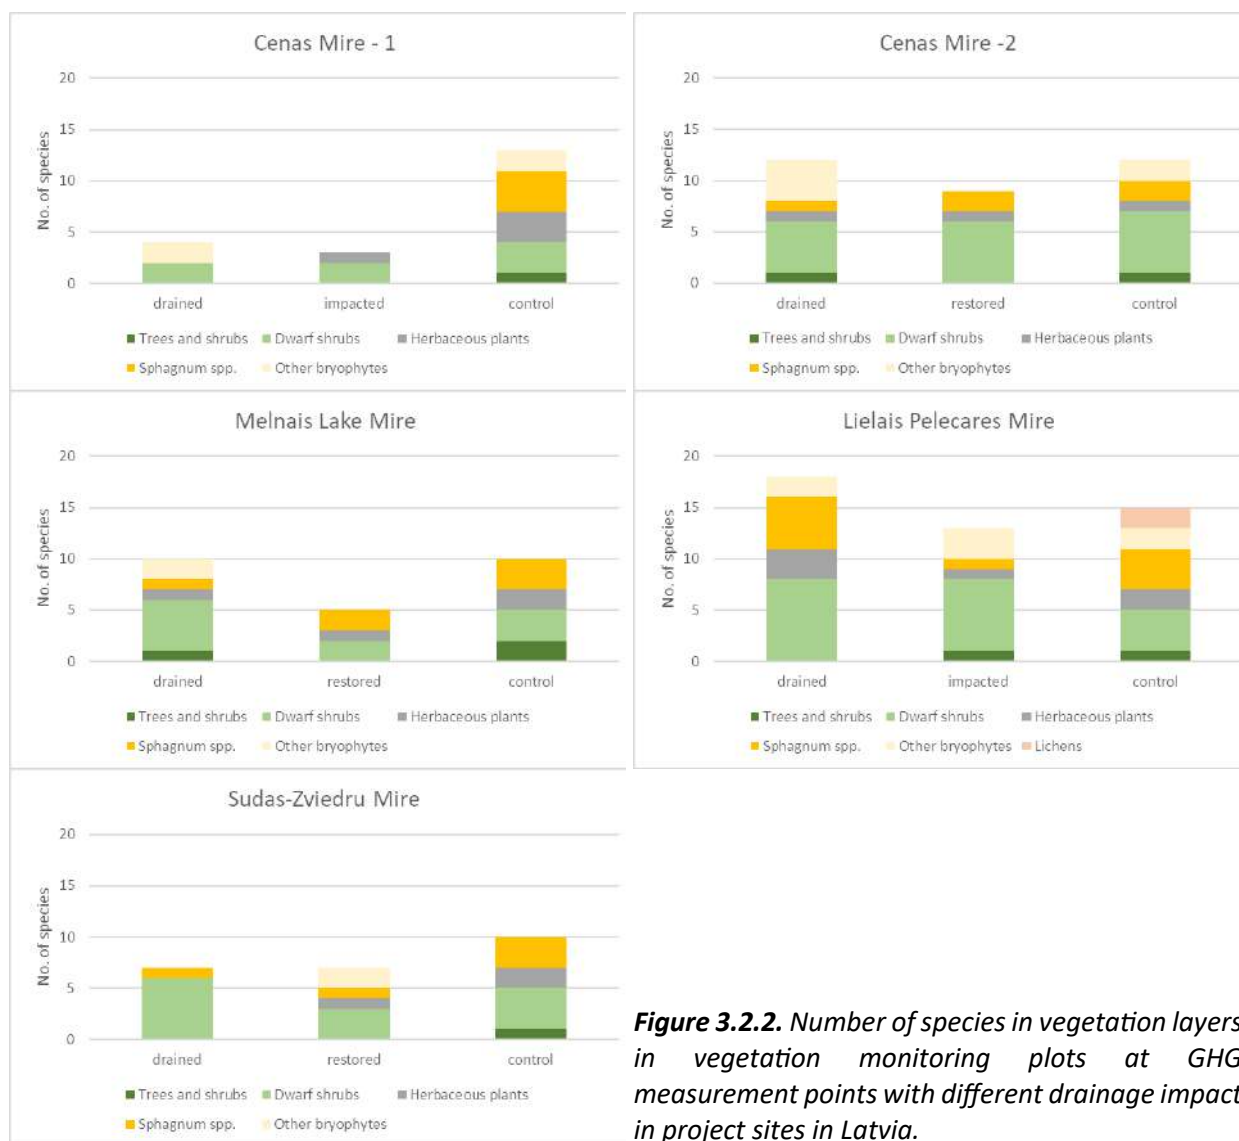
**Figure 3.2.2.** Number of species in vegetation layers in vegetation monitoring plots at GHG measurement points with different drainage impact in project sites in Latvia.

Some of the species richness trends described above are also found in the GHG measurement transects (Figure 3.2.2). Number of drought resistant dwarf shrub species is higher in drainage impacted plots in all project sites except Cena Mire. Whereas the number of herbaceous plants and *Sphagnum* species shows relation with natural plots in all plots except Lielais Pelečāre Mire. In general, it cannot be argued that a natural, active raised bog has a higher species diversity than a degraded mire. However, it can be observed that the species composition is more balanced between different vegetation layers in natural habitats. Whereas in the drained parts of the mire, one of the species groups clearly dominates and disrupts the balance. Since the data series of the vegetation monitoring are still relatively short, it is not possible to analyse the restoration progress after the stabilization of the hydrological regime.

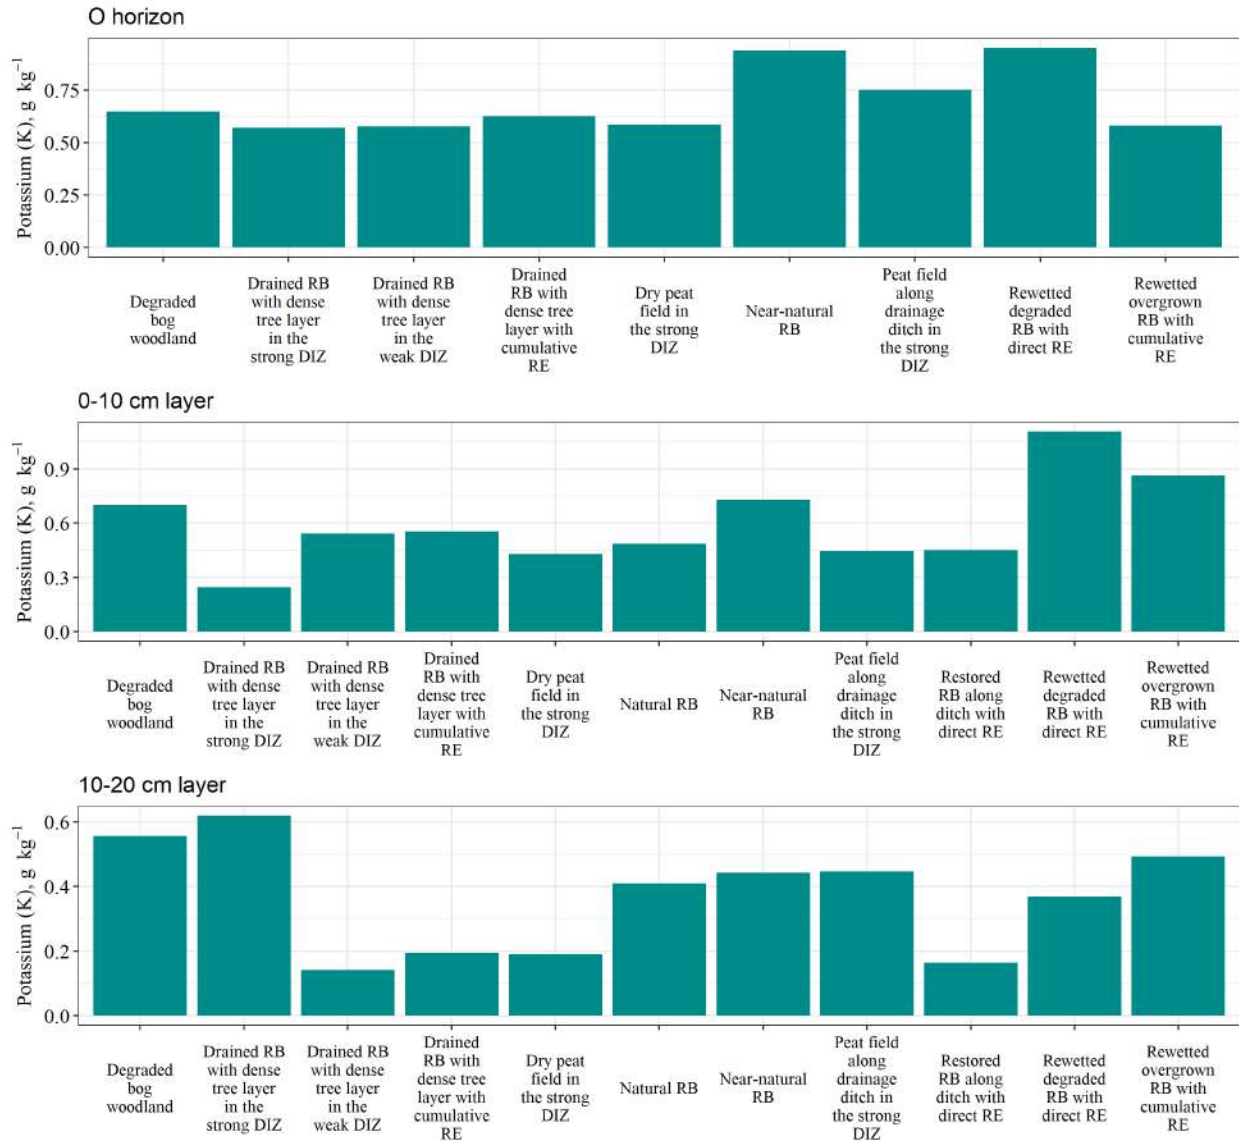
**Figure 3.3.10.** Concentrated nitric acid ( $\text{HNO}_3$ ) extractable potassium (K) concentration in different soil layers (O horizon, 0-10 cm and 10-20 cm soil layer) by habitat types<sup>9</sup>.
