Hydrological, vegetation, greenhouse gas and GEST monitoring in project sites in Latvia

1st Monitoring report

LIFE21 - CCM - LV - LIFE – PeatCarbon

Peatland restoration for greenhouse gas emission reduction and carbon sequestration in the Baltic Sea region

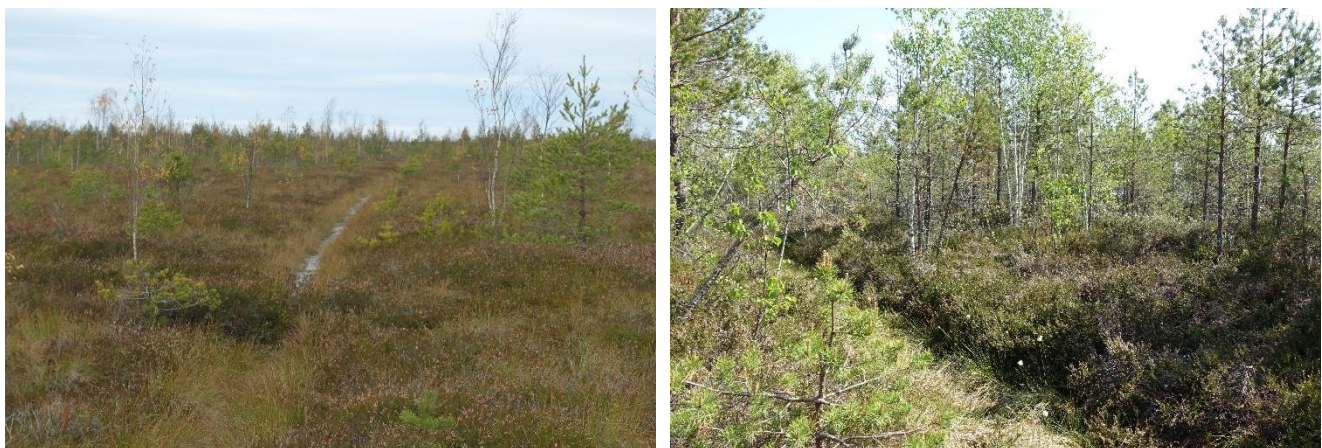
Figure 1.3. Drainage system with peat dams from 2006 (left) and still functioning ditch where restoration will be performed during LIFE PeatCarbon project (right) in the SE part of Cenas Mire. Images: © L. Strazdiņa

The territory of Cenas Mire Nature Reserve has changed little in the period from middle of the 19th century to the middle of the 20th century. Later, the entire territory of the Nature Reserve and the adjacent mire massifs were little affected because of human economic activity. Change begins after World War 2. Around 1962, peat extraction was started in the areas adjacent to the SE of the Nature Reserve. Ditches have also been created near to Skaists Lake (Figure 1.2). Around 1967, the peat extraction fields were further expanded, reaching the S and W border of the Nature Reserve. Later, even more ditches have been installed in the S part of the mire (Figure 1.3).

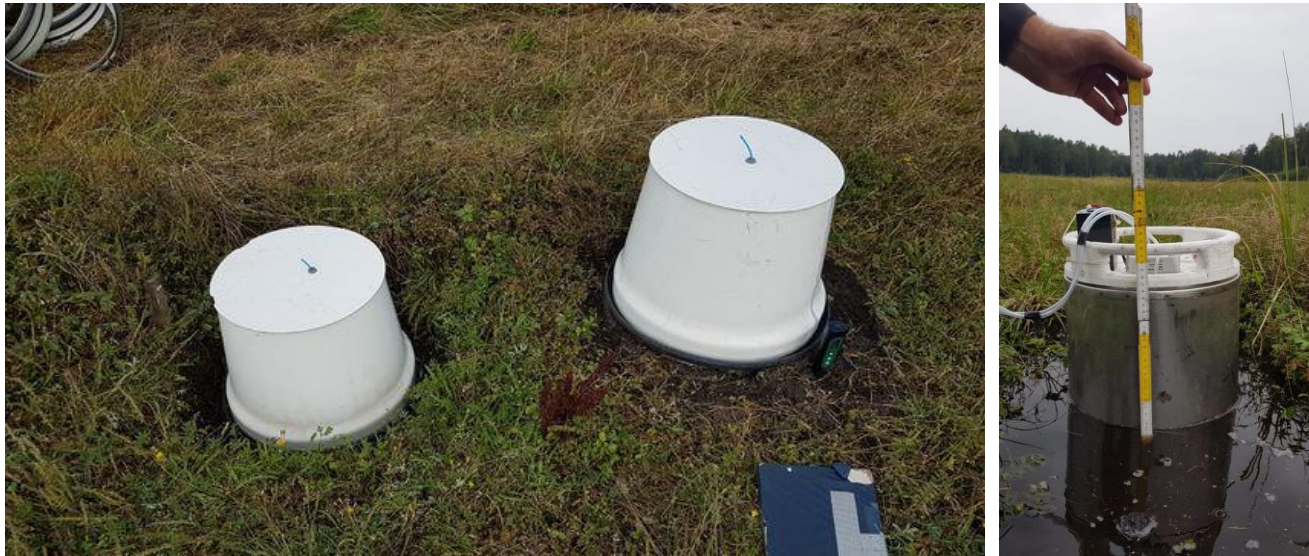
Figure 2.7. Gas measurement chambers (left) and soil heterotrophic measurement chamber (right).

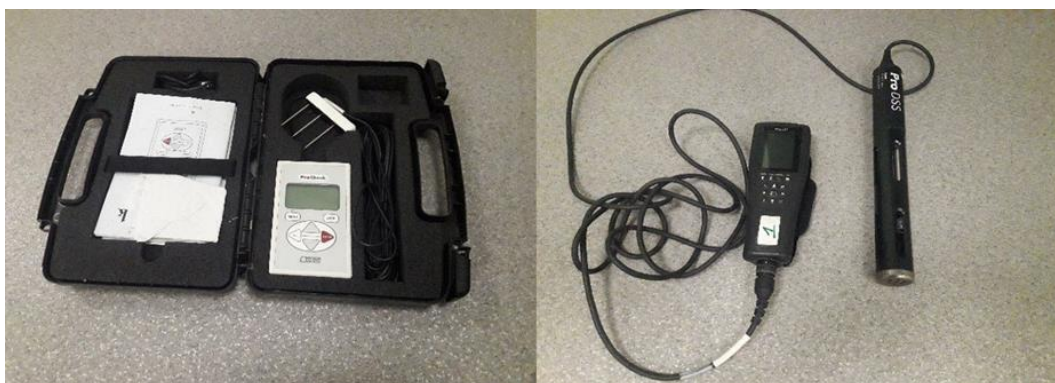
Figure 2.8. Equipment for measuring soil temperature, moisture content and groundwater properties.
Image: © M. Vanags-Duka

Simultaneously with the measurement of the groundwater level, measurements and observations of the factors influencing the gas exchange of the ecosystem are carried out. Typically, the determination of groundwater characteristics such as depth, temperature, dissolved oxygen (ODO), electrical conductivity, pH and oxidation-reduction potential (ORP) is performed with the ProDSS probe, as well as groundwater samples (NO_3^-) and ammonium (NH_4^+) ion are collected, as well as other parameters for determining the composition in the laboratory. Temperature measurements of the air and soil at a depth of 5 cm are performed in parallel, and the electrical conductivity of the soil and the moisture level in the soil are determined with Procheck (Figure 2.8).

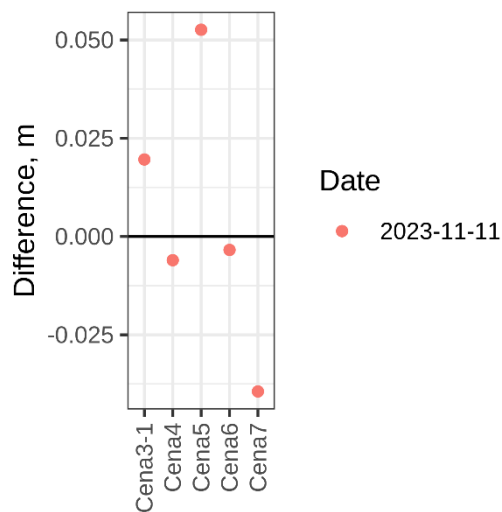
Figure 3.1. The difference between automatic and manual water level measured at all observation points is 0.05 m or less, indicating overall good measurement quality.

In Cenas Mire, good agreement was found between manual and automatic water level measurements (Figure 3.1). Differences are no greater than 5 cm, which overall corresponds to the uncertainty sum of manual and automatic measurements.

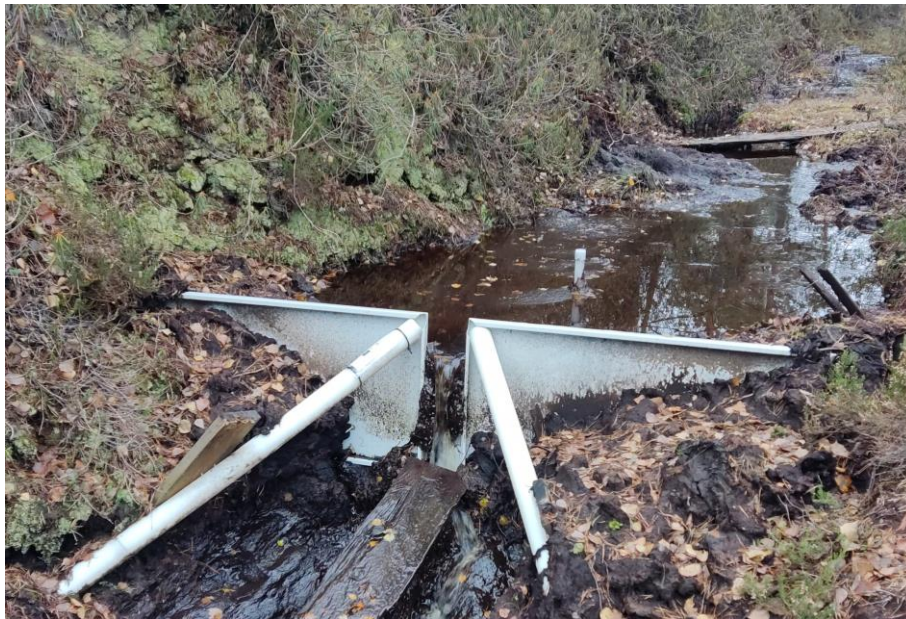
Figure 3.4. A discharge measurement spillway (monitoring point Cena8) clogged with eroded peat, November 10, 2023. Image: © A. Kalvāns

The water discharge (runoff) monitoring in Cenas Mire was planned in the hydrological regime restoration area No. 1 (Kūdras lauks (Atpūtas)), at observation point Cena8. Upon inspecting the installed observation point in the autumn of 2023, it was discovered that the constructed spillway had become clogged with eroded peat (Figure 3.4), rendering the measurement results unusable. It is planned to relocate the discharge monitoring point to a ditch where the accumulation of such peat erosion material is not anticipated in a restoration area No.2 “Akača dambis”.

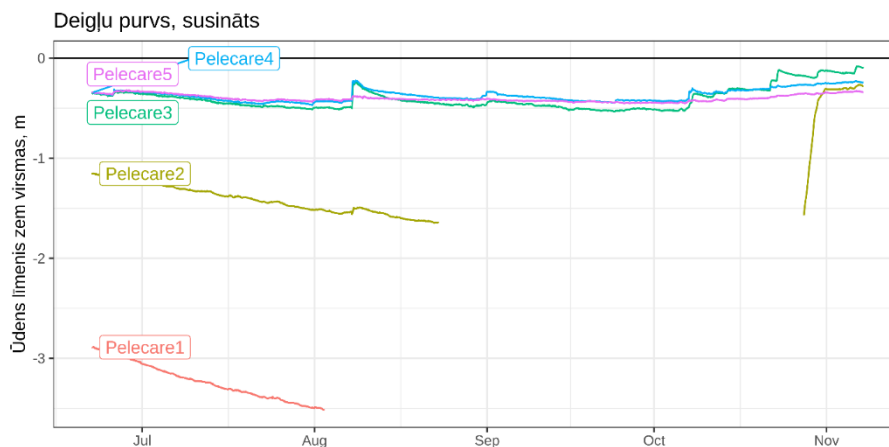
Figure 3.7. Observed water level in the drained part of the Deigļu Mire (southern part of the Lielais Pelečāres Mire): Pelecare1 – dry forest at the edge of the bog; Pelecare2, Pelecare3, Pelecare4 – bog woodland, partially formed because of drainage on the slope of the raised bog dome; Pelecare5 – observation point least affected by the drainage at the bog side of the last drainage ditch.

A gradual decrease in water level was observed in the boreholes Pelecare1 (dry forest) and Pelecare2 (bog woodland) during the summer of 2023. By the end of October, the water level in the bog woodland (Pelecare2) rapidly increased and stabilized at a depth of approximately 0.3 m below ground level, while in the dry forest water level remained below the installation depth of the water level probe. The rise in water level is likely associated with the gradual saturation of the dry peat after exceptionally dry summer of 2023, replenishing with precipitation water and to resumed diffuse flow from the raised bog.

In the degraded part of the bog, at observation points Pelecare3 and Pelecare4, where a bog woodland established because of the drainage, a gradual decrease in relative water level was observed during the summer (July) (Figure 3.7, Figure 3.8). This trend was interrupted by a sharp rise in level at the beginning of August, presumably associated with heavy rainfall. However, the decrease in level resumes in August and September, reaching the minimum in the second half of September (0.53 m below ground level at observation point Pelecare3). The water level range reaches 0.45 m (Table3.2).

At the observation point Pelecare5, located in the bog side of the last drainage ditch, the water level fluctuation range is from 0.32 to 0.45 m below ground level (Figure 3.8) - significantly smaller than in other observation points. However, the water table remains well below the recorded soil surface, presumably due to its location on a bog hummock.

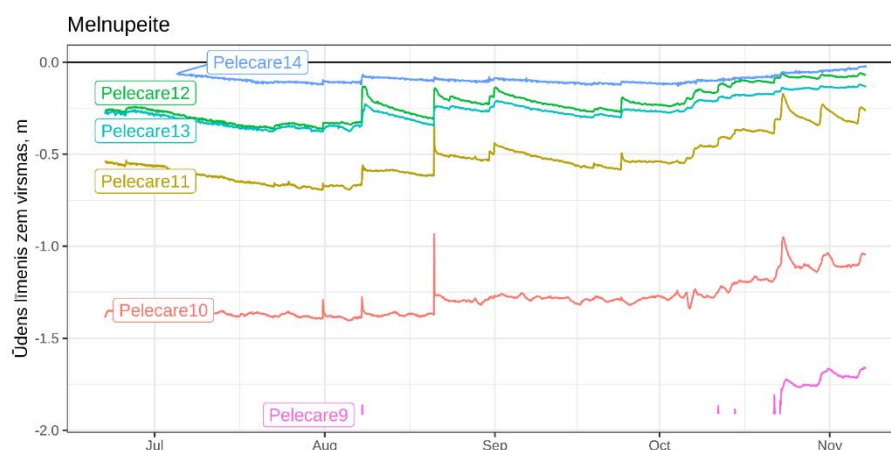
Figure 3.9. Observed water level in the southern part of Lielais Pelečāres Mire, within the drainage basin of watercourse of national significance named “Nr.25” (Malnupeite) and Deguma Lake: Pelecare9 – Malnupeite River (watercourse of national significance named “Nr.25”); Pelecare10, Pelecare11, Pelecare12, Pelecare13 – profile of observation points perpendicular to the deep collector ditch (Malnupeite) within the Lielais Pelečāres Mire; Pelecare14 – water level in Deguma Lake.

During the reporting period, water flow in ditch Nr.25 (Pelecare9) outside the Lielais Pelečāres Mire appeared only in the second half of October 2023 (Figure 3.9), presumably due to an increase in groundwater levels because of autumn rains. During the observation period, one instrumental flow measurement was carried out there using the salt tracer method: on November 7, 2023, at 12:26, the calculated discharge was 32.6 l/s and the corresponding relative water level was -1.66 m relative to the zero mark of the observation point.

In the profile line of observation points (Pelecare10 to Pelecare13), perpendicular to the deep collector ditch (Malnupeite) within heavily drained section of the raised bog, a gradual increase in water level away from the collector ditch was observed (Figure 3.9). Several episodes of intense rainfall starting from August 2023 are noted as rapid rise in water level followed by a gradual decline. In the second half of October, at observation points further from the collector ditch (Pelecare12 and Pelecare13), the water level stabilizes relatively close to the ground surface (<0.25 m), while at points closer to the drainage ditch, rapid level fluctuations persist during the autumn period.

In Deguma Lake (Pelecare14), minor fluctuations in water level are observed. The water level range was only 0.12m, contrasting with significant fluctuations at other observation points.

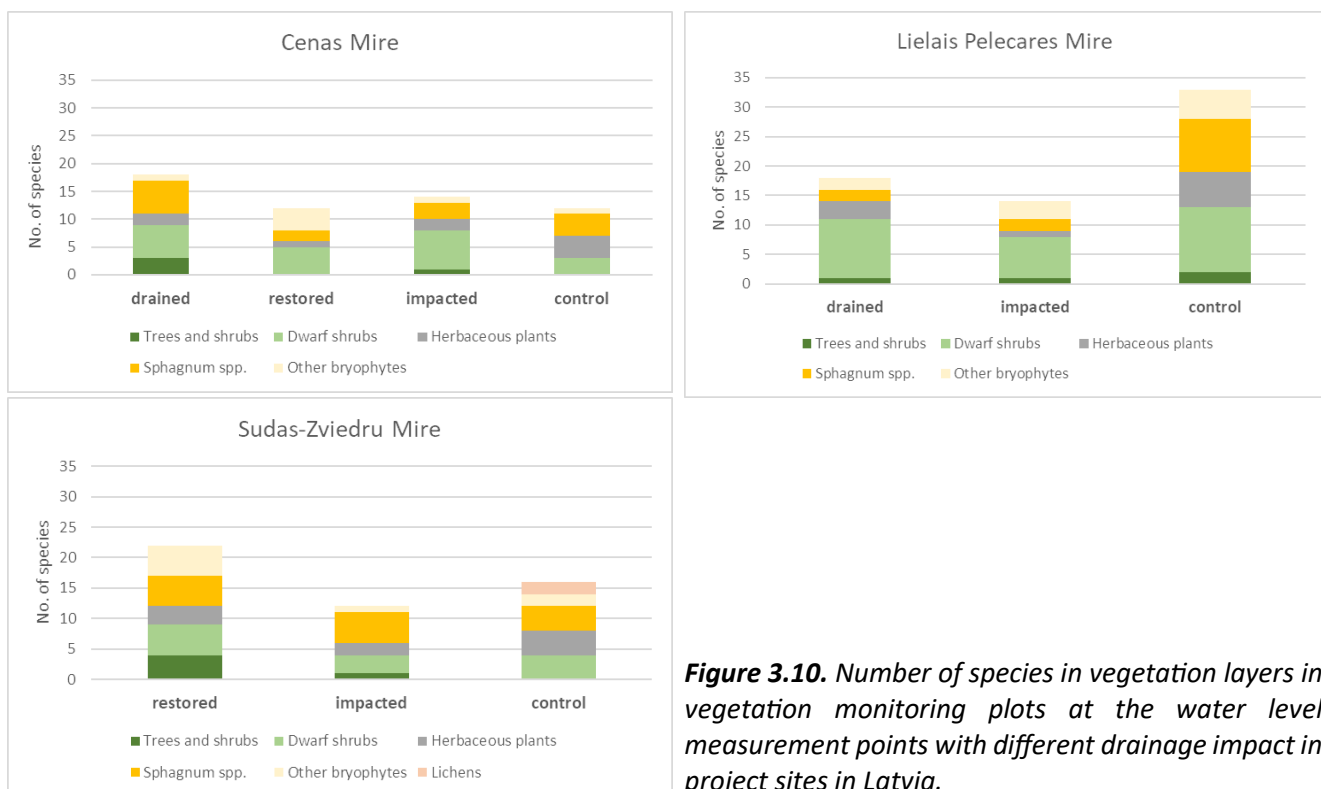
Figure 3.10. Number of species in vegetation layers in vegetation monitoring plots at the water level measurement points with different drainage impact in project sites in Latvia.

The species composition from all vegetation monitoring plots (including plots from GHG transects and GEST points) shows that the highest species richness was in Melnais Lake Mire (53), followed by Cenas Mire with 44 species and the Lielais Pelečāres Mire with a total of 39 species of vascular plants, bryophytes, and lichens. The lowest number of species was found in Sudas-Zviedru Mire with 32 species (Appendix 6.6). Altogether, 68 species were found at least in one monitoring plot. Some of the most common species that were recorded in all project sites are *Betula pendula*, *Pinus sylvestris*, *Andromeda polifolia*, *Calluna vulgaris*, *Drosera rotundifolia*, *Empetrum nigrum*, *Eriophorum vaginatum*, *Ledum palustre*, *Oxycoccus palustris*, *Rhynchospora alba*, *Rubus chamaemorus*, *Vaccinium uliginosum*, *Dicranum polysetum*, *Pleurozium schreberi*, *Sphagnum cuspidatum*, *S. fuscum*, and *S. medium*.

The vegetation at the water level measurement points varies greatly between the sample plots with different drainage impact - depending on whether they have been previously restored, significantly or only indirectly drained, or not affected by changes in the water regime at all. Accordingly, the number of trees, shrubs and dwarf shrubs is higher in the drained plots, while the number of herbaceous plants is higher in the natural habitats (Figure 3.10). The most common tree species are *Betula pendula* and *B. pubescens*, *Pinus sylvestris*, occasionally also *Frangula alnus* and *Picea abies*. Dwarf shrub layer is species rich and especially in Lielais Pelecares Mire with 11 species. The most common species are *Andromeda polifolia*, *Calluna vulgaris*, *Chamaedaphne calyculata*, *Ledum palustre*, *Oxycoccus palustris*, *Rubus chamaemorus*, *Vaccinium uliginosum*. *Sphagnum spp.* does not show a certain relationship with the drainage impact, as in Lielais Pelecares Mire they are more common in the natural part of the bog, in Cenas Mire - in the degraded part, while in Sudas-Zviedru Mire the number of *Sphagnum* is relatively similar in all plot types. The other bryophyte species like *Pleurozium schreberi*, *Dicranum polysetum* and other forest mosses are more common in restored bog monitoring plots.

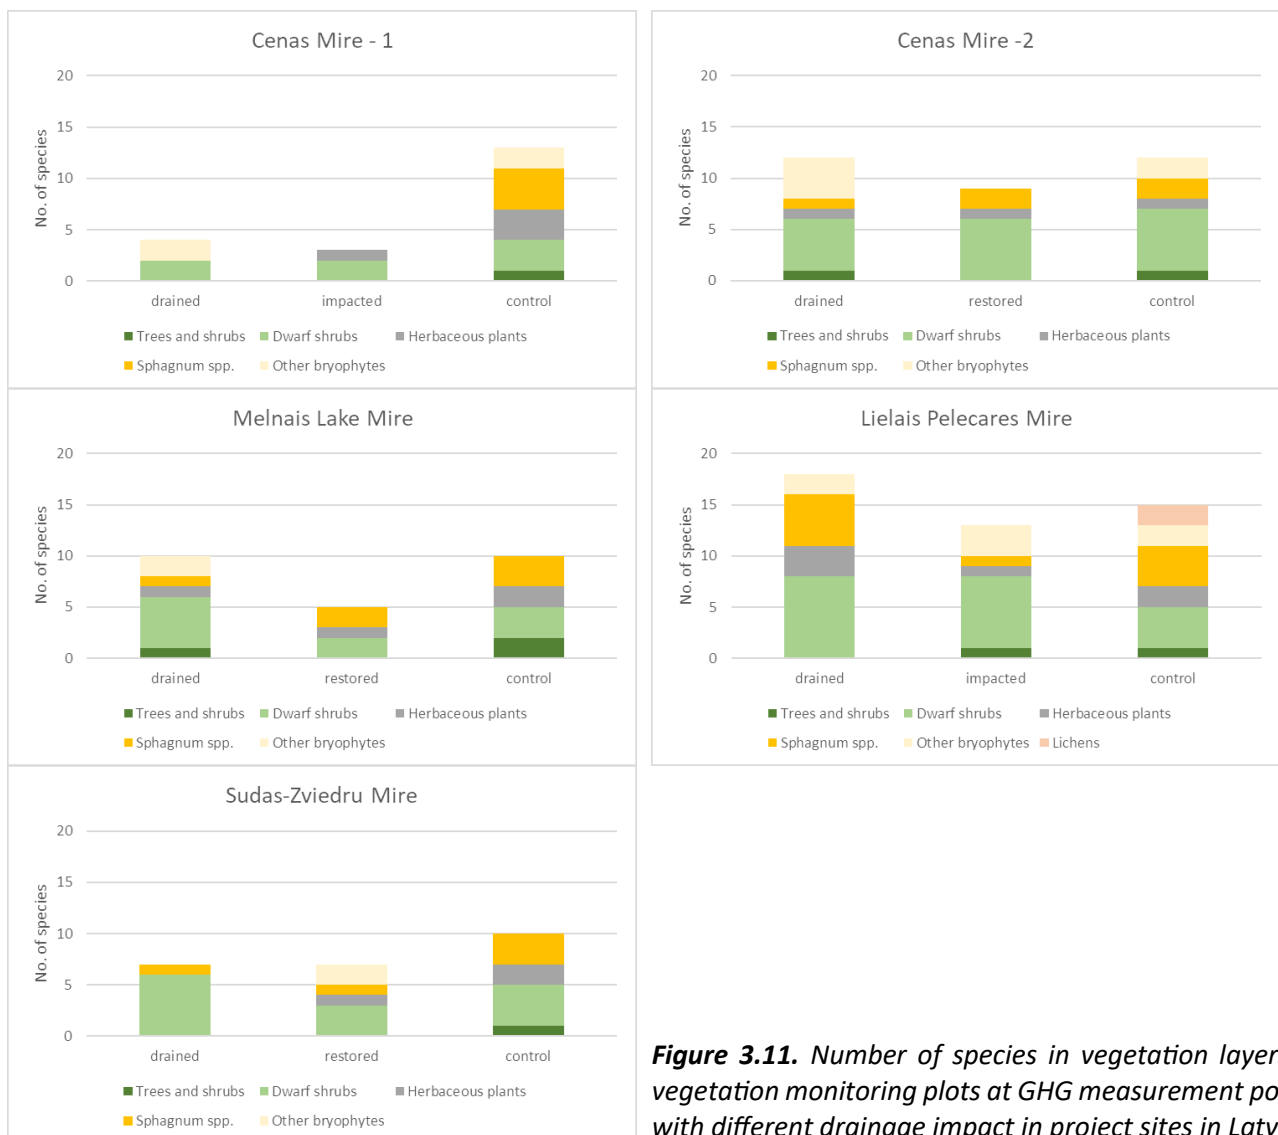
Figure 3.11. Number of species in vegetation layers in vegetation monitoring plots at GHG measurement points with different drainage impact in project sites in Latvia.

Some of the species richness trends described above are also found in the GHG measurement transects (Figure 3.11). Number of drought resistant dwarf shrub species is higher in drainage impacted plots in all project sites except Cenas Mire. Whereas the number of herbaceous plants and *Sphagnum* species shows relation with natural plots in all plots except Lielais Pelečāres Mire.

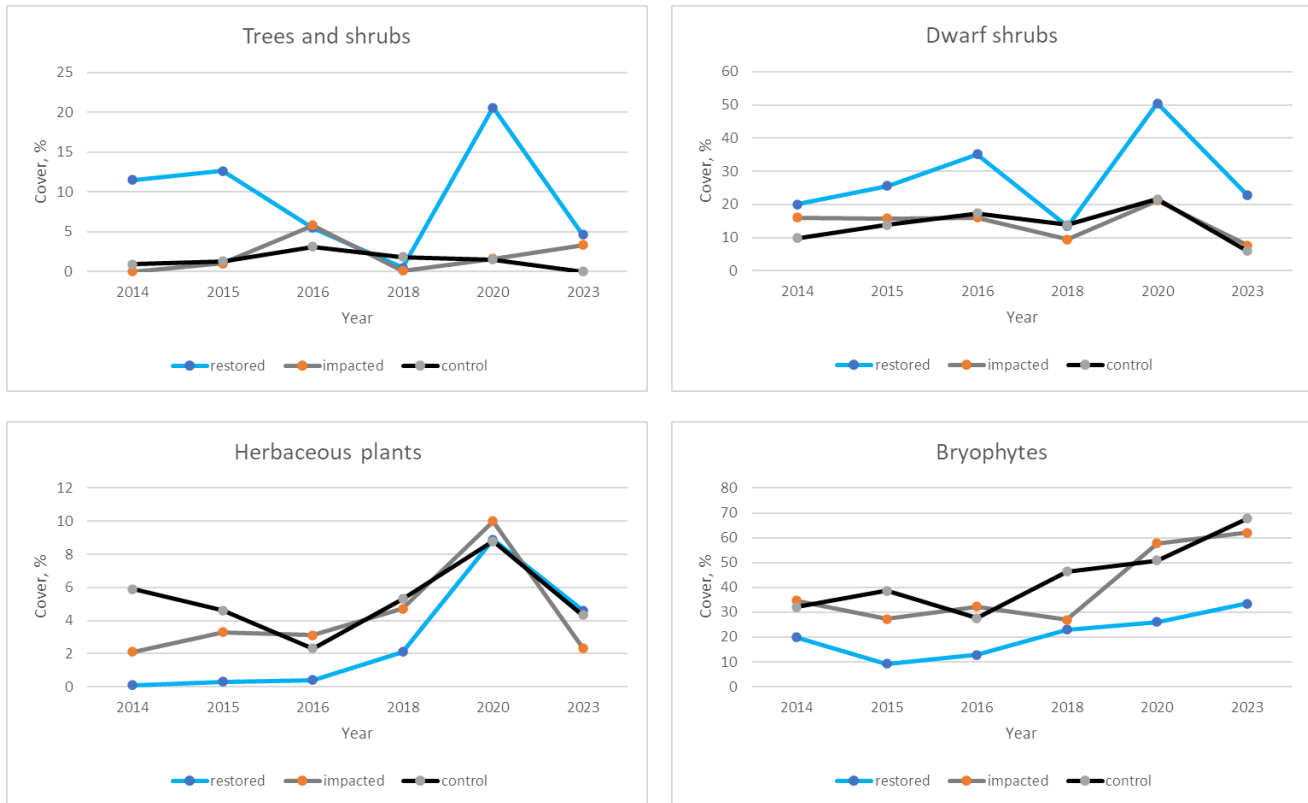
Figure 3.13. Changes of the total cover (%) of species in different vegetation layers ((i) trees and shrubs; (ii) dwarf shrubs; (iii) herbaceous plants; (iv) bryophytes) during nine years in Sudas-Zviedru Mire. Hydrology stabilization in the mire was completed in 2017.

The withering of trees near the restored ditches was also visually assessed. Positive changes over time are also expected in the dwarf shrub layer. The total cover of *Calluna vulgaris* could slowly decrease and be replaced by herbaceous plants or *Sphagnum* species.

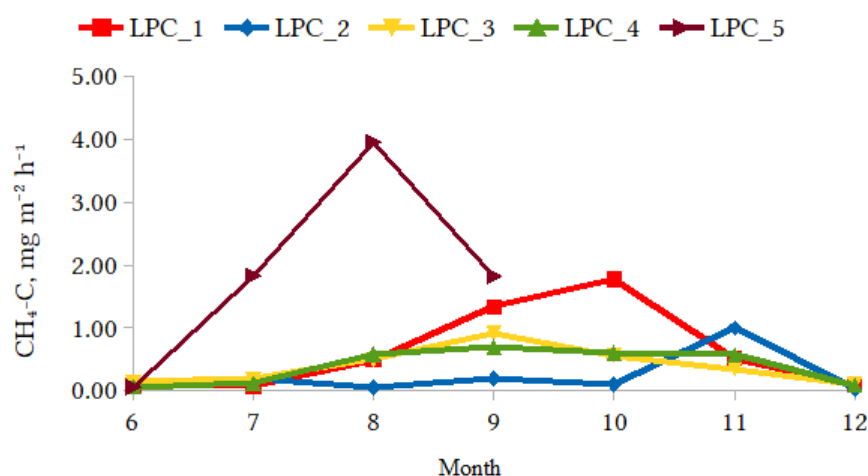
Figure 3.15. Methane emission results of 2023 season compared between all GHG monitoring sites in Latvia.

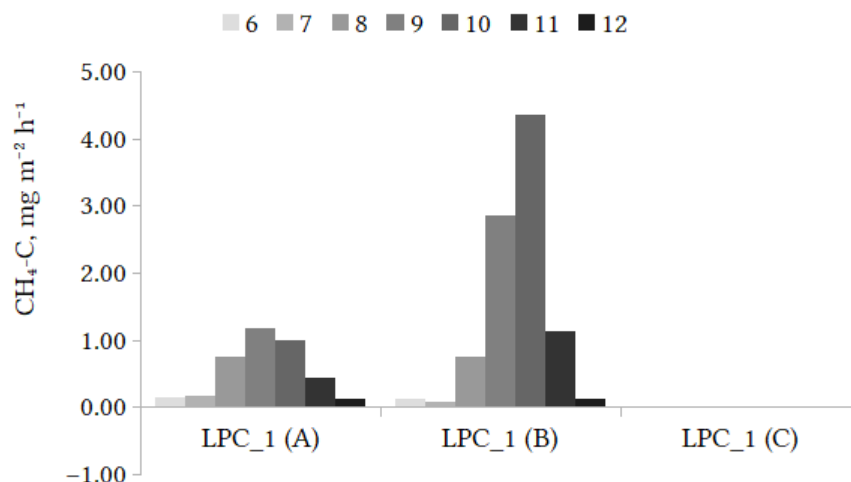
Figure 3.17. Methane CH_4 emission comparison between subplots in Sudas-Zviedru Mire, year 2023.
