Peatland hydrological monitoring results in Latvian project sites

Andis Kalvāns, Konrāds Popovs University of Latvia LIFE PeatCarbon project No. 01074396-LIFE21-CCM-LV-LIFE Project Scientific Group Meeting September 26, 2024

Hydrological monitoring

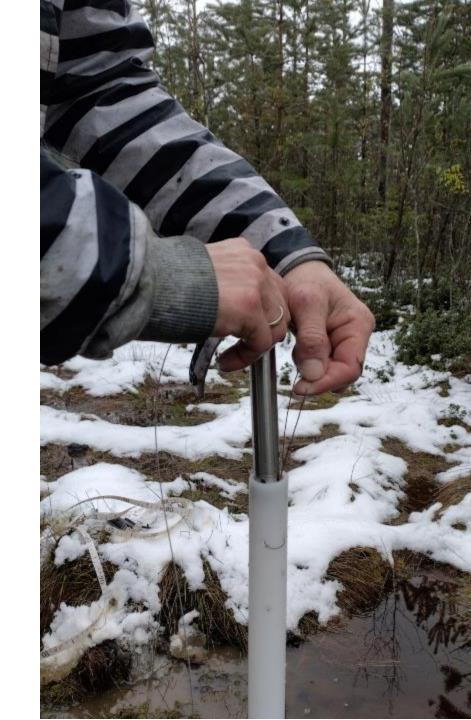
Summary

- 4 mires
- 53 water level monitoring sites
- 2 weather stations
- 2 soil water stations
- 4 surface water sampling locations
- 2 discharge estimation sites
